M Y R N A · S A X E
CONSERVATORS · ART
AND · ARCHITECTURE

THE ASTORIA COLUMN CONSERVATION STUDY

FEBRUARY 1990

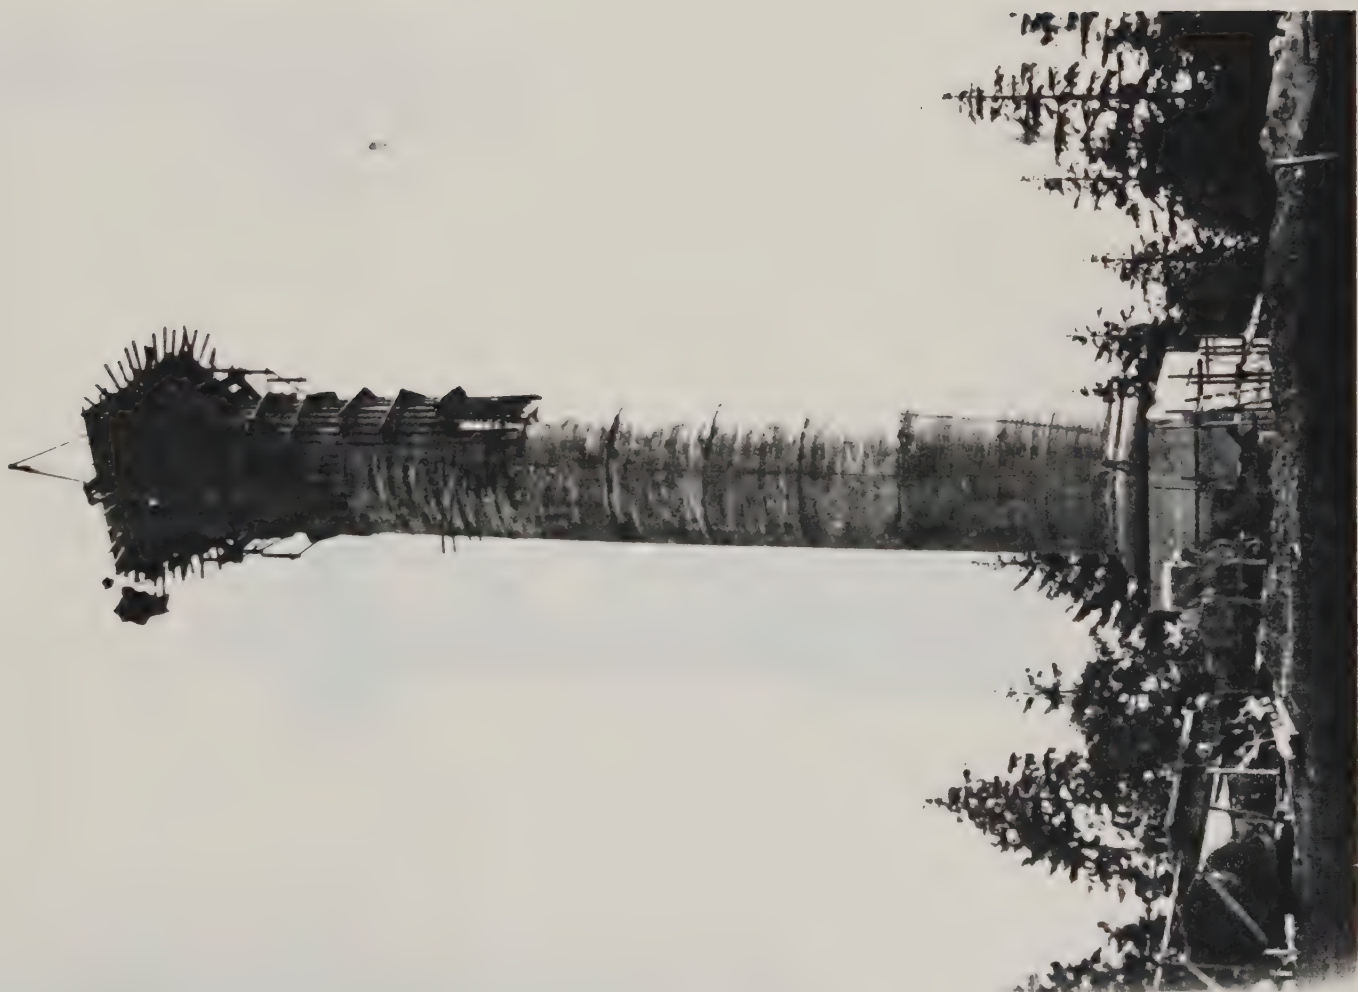
The monument was built of poured concrete. Both vertical and horizontal re-bar was used. See Figure 7. After completion, the concrete was coated with a layer of grey cement mortar. The quality of design, materials and workmanship represent the finest state of the art construction for that period.

Fig. 7 Photo Astoria Column Southwest Face,
In Construction- 1926

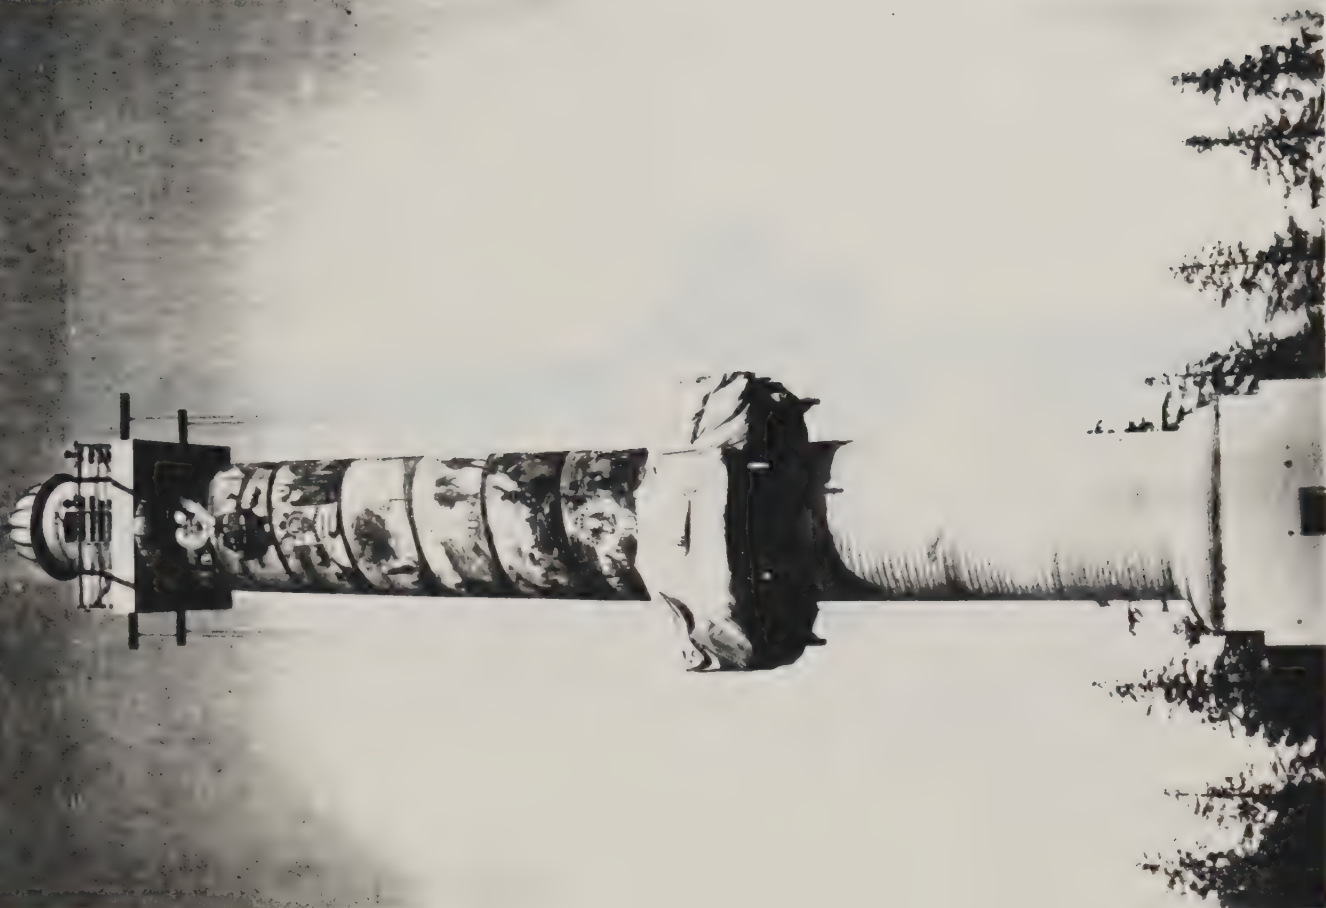
Fig 8 Photo Astoria Column West Face,
In Progress-1926

When executing the artwork on the Astoria column, the artist adapted traditional Italian technique for use with portland cement plaster. The chocolate brown base coat was applied with a formula containing dark river sand, pigment and portland cement. He then carved his designs into the still soft cement plaster. With a hanging scaffolding that did not permit control of cure in an unusually wet summer, he applied the thin outerlayer colors of sea, sky, skin, etc, with a high lime content plaster which could be mixed and applied smoothly and rapidly. The formula was highly porous and ill adapted to the Astoria climate. It began to deteriorate with loss and staining within one year after completion. See Figures 8 to 18.

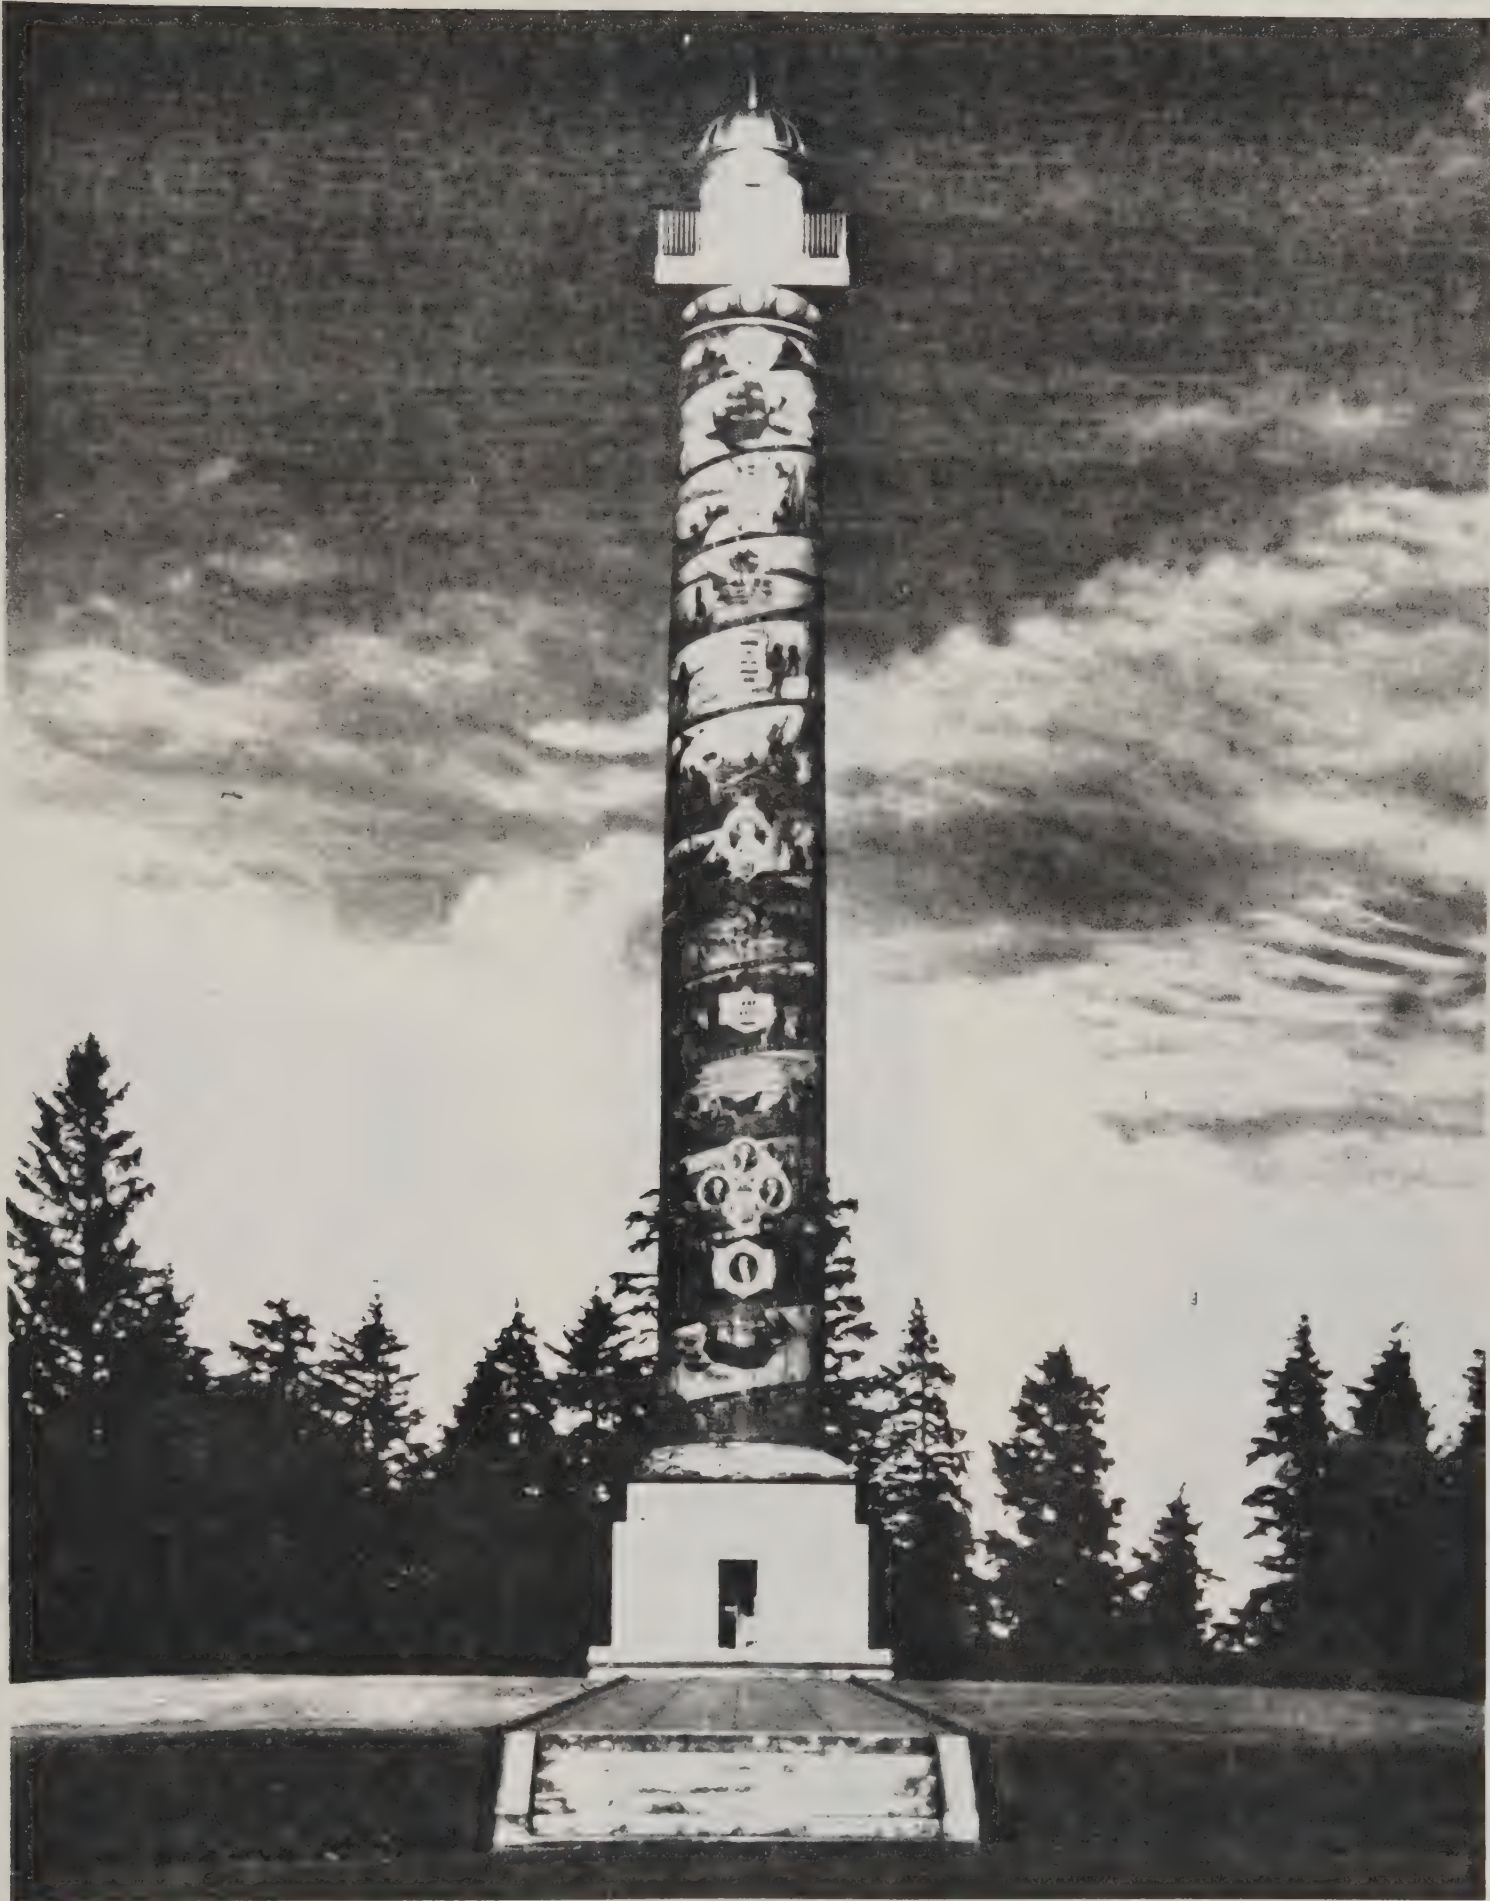
Fig. 18 Photo Astoria Column West Face-1927? Note drip stains.

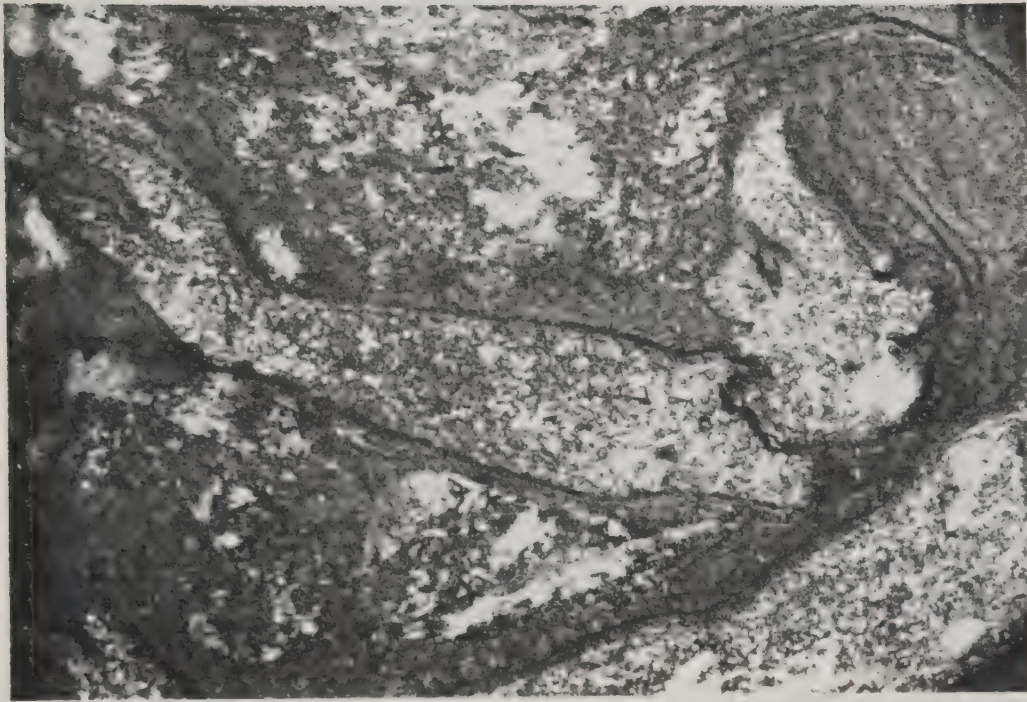
Mold was evident on one hundred per-cent of the surface. The mold was treated and removed in the 1989 treatment. See Figures 55 and 56, before and after moldicide treatment, respectively.

Fig. 55 Photo Astoria Column Detail Before Moldicide Treatment.

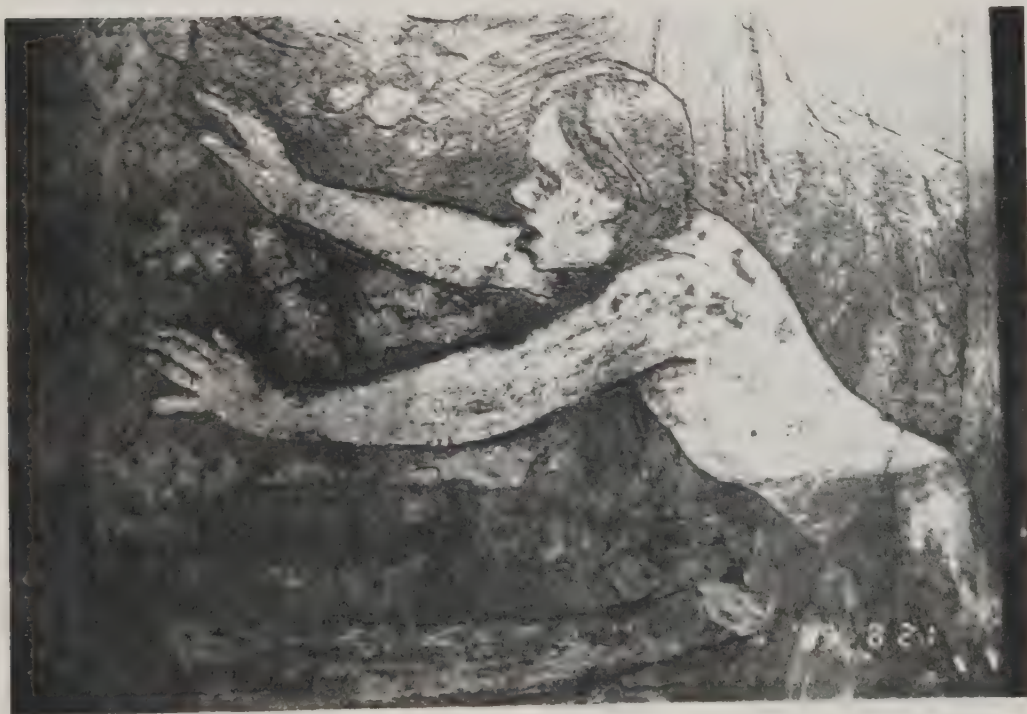
Fig. 56 Photo Astoria Column Detail After Moldicide And Oil Removal.

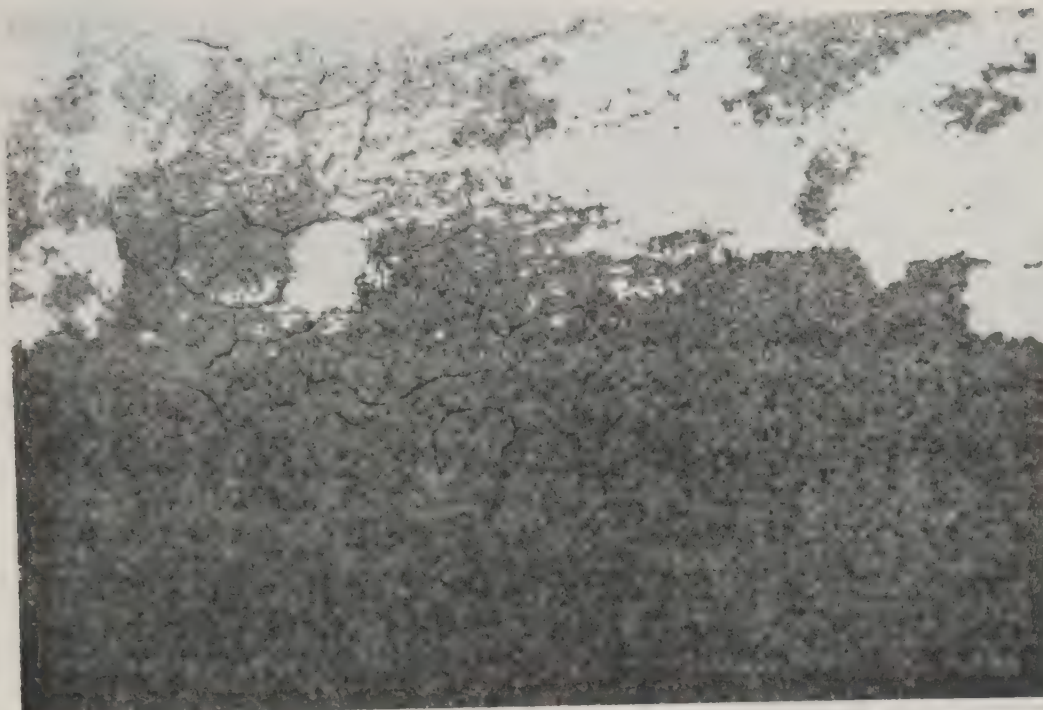
Shrinkage cracks on the brown layer are visible in some areas. When properly covered by a new outer layer of pigmented plaster, they pose no harm. See Figure 57, shrinkage cracks in brown layer.

Fig. 57 Photo Astoria Column Detail Shrinkage Cracks In Brown Layer-AUG 1989

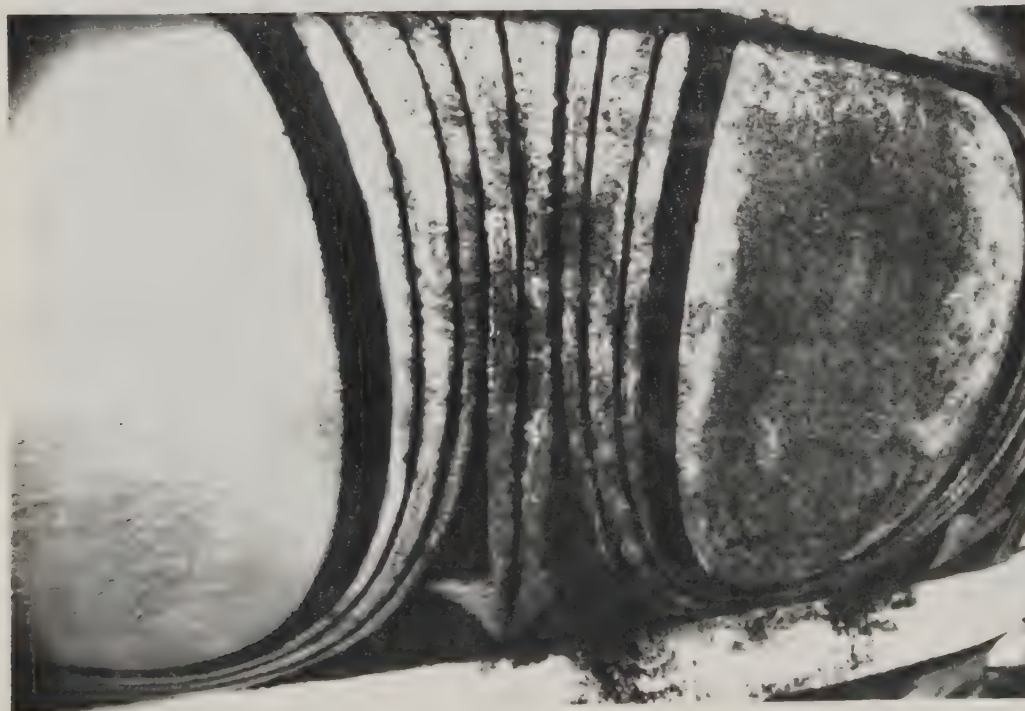
Improper drainage on the observation platform has caused staining on the painted cornice. See Figure 58

Fig. 58 Photo Astoria Column Detail Egg and Dart Cornice Drip Line Damage Before Cleaning-JUL 1989

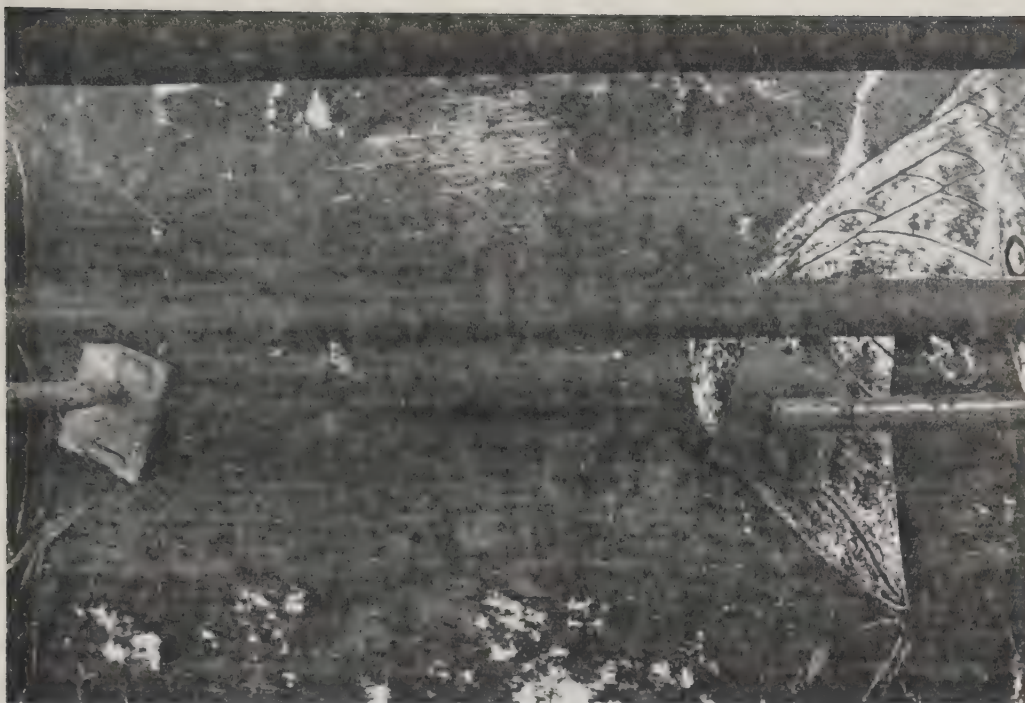
About five per-cent of the brown base coat has eroded to the depth of carvings, the design is lost except for clues given in historic photographs and the extant scale model. The erosion is specifically in areas exposed to the most extreme wether on the north and south faces or where the brown layer was applied in to thin a layer. See Figure 59 Photograph, eroded area.

Fig 59 Photo Astoria Column Detail Brown Layer Eroded-AUG 1989

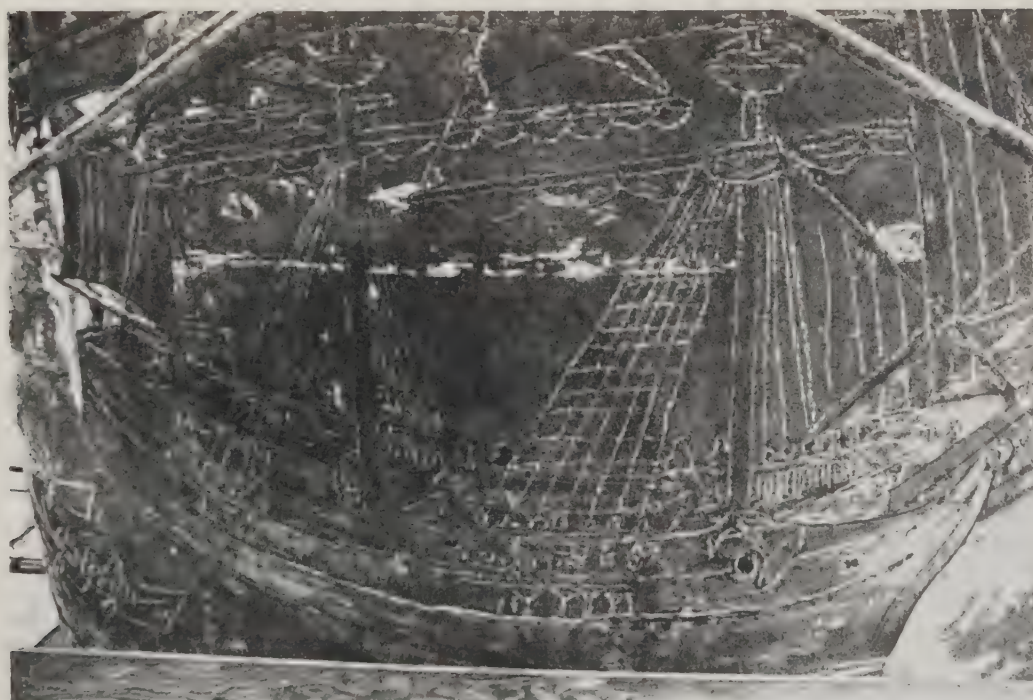
About thirty per-cent of massive areas of sea and sky backgrounds are missing, primarily on the west and south where delimitation was aided by differential thermal expansion. See Figures 60, 61, 62.

Fig. 60 Photo Astoria Column Detail Sea and Sky Background Lost-AUG 1989

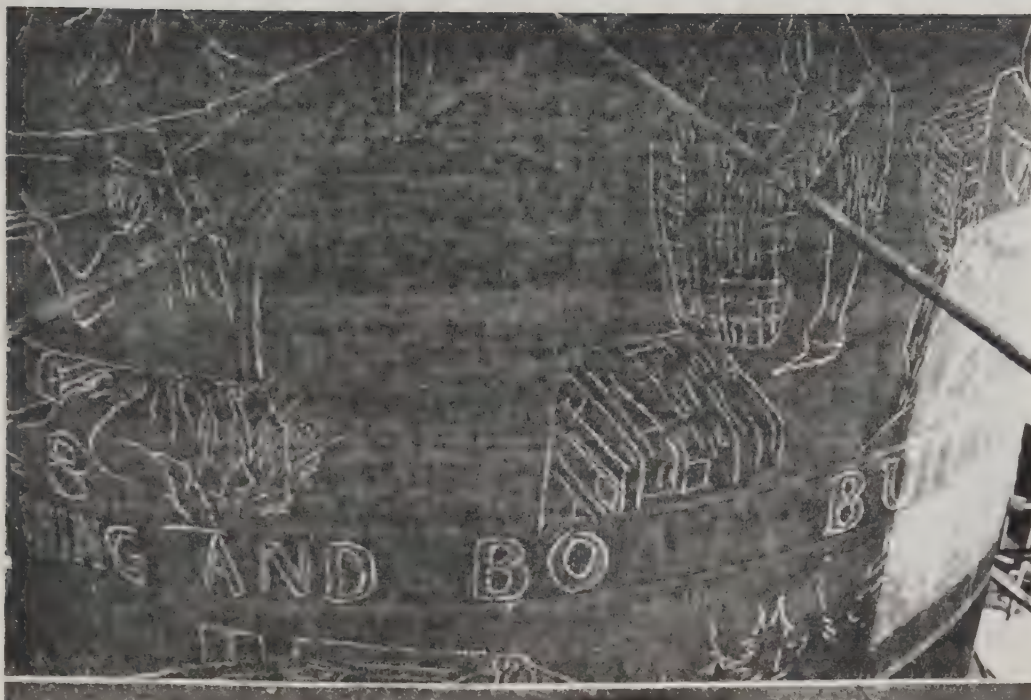
Fig. 61 Photo Astoria Column Detail All Light Colors Lost-AUG 1989

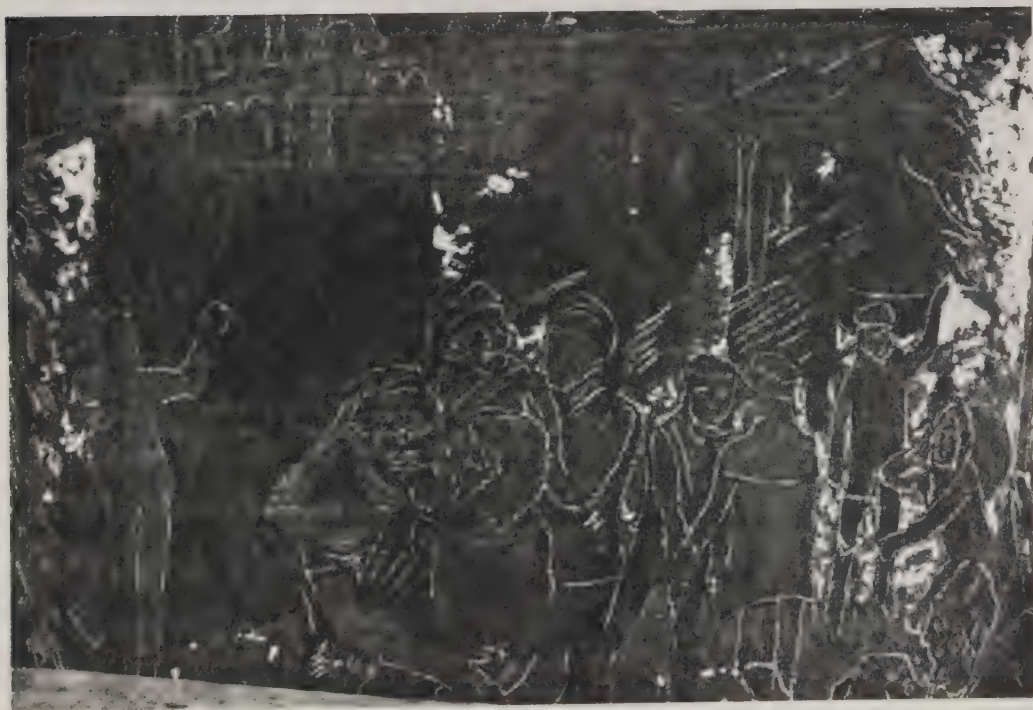
Fig. 62 Photo Astoria Column Detail Carvings Outlined in Chalk-AUG 1989

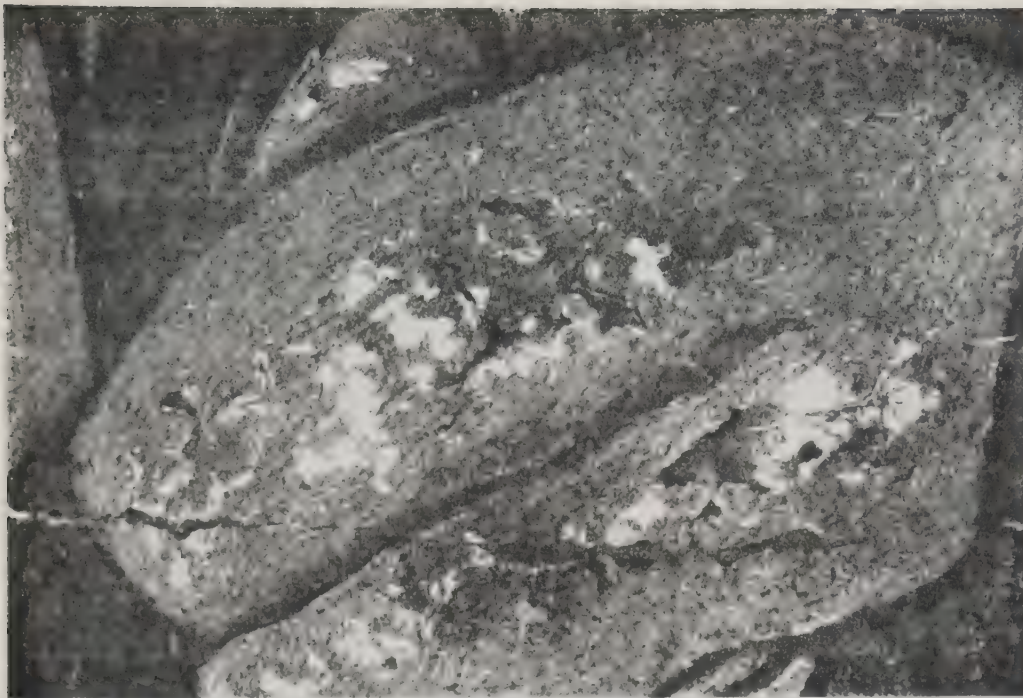
About twenty per-cent of the artwork has losses of small spots of color. These are in areas that were not well prepared during the 1936 restoration. See Figures 63 through 70

Fig. 63 Photo Astoria Column Detail Spotty Losses-AUG 1989

The remainder of the 1936 restoration is intact without need of treatment, other than regular preventive care. See Figures 63, 64, 65, 66.

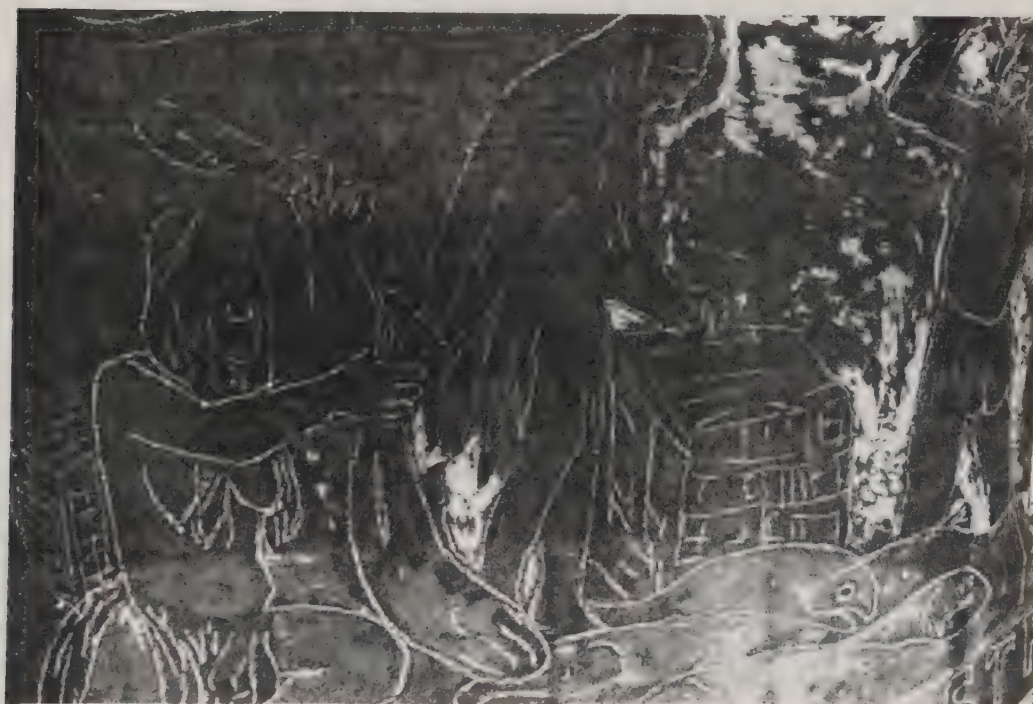
Fig. 66 Photo Astoria Column Detail Background And Skin Lost-AUG 1989

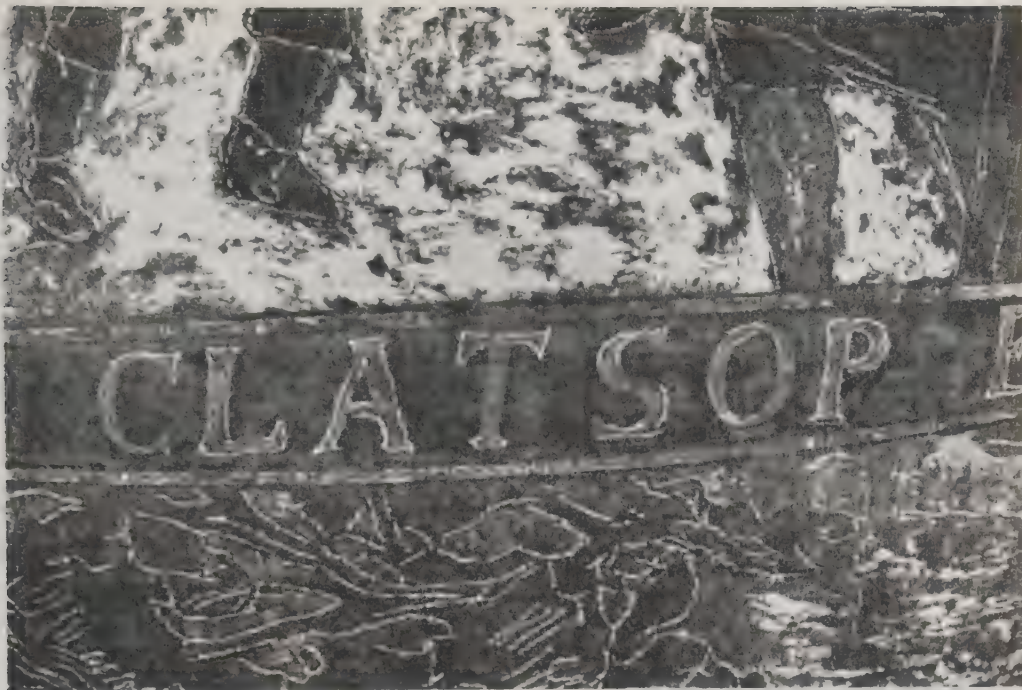
Vertical cracks through the concrete which run the full length of the south, east and west face are caused by temperature fluctuations in those directions. The north face, having a more stable temperature is not cracked. The cracks follow the lines etched in the brown layer by the artist to serve as register lines for his full size cartoons. The cracks were previously filled with an epoxy grout which has deteriorated and separated as the cracks continue to move as self made, and necessary, expansion joints. See Figure 67.

Fig. 67 Photo Astoria Column Detail Spotty Losses-AUG 1989

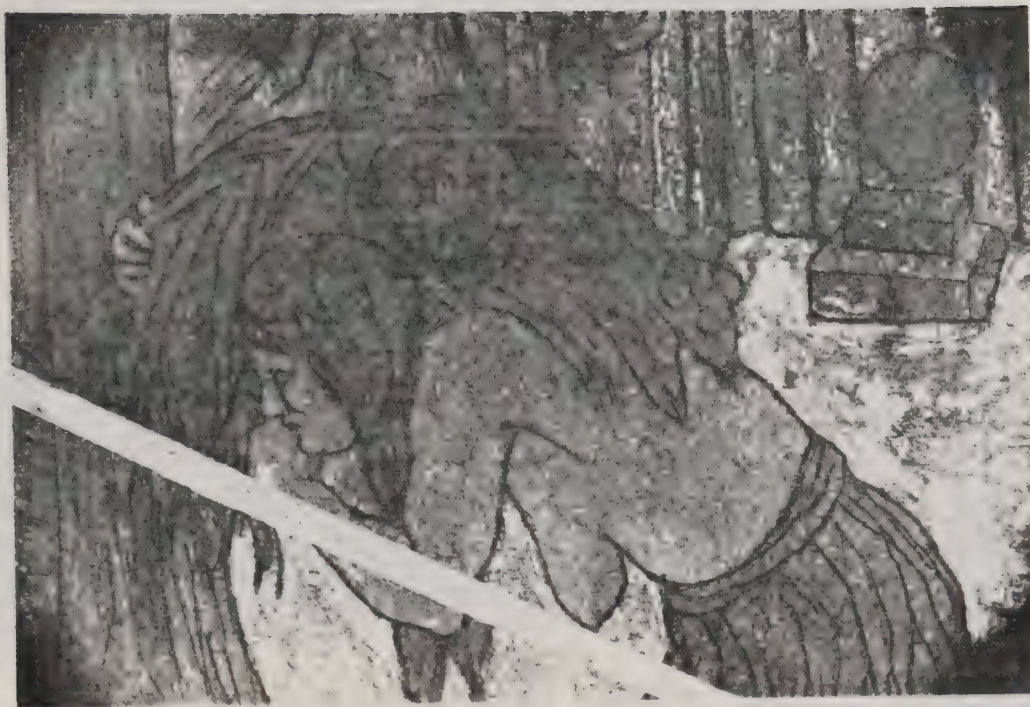
Fig. 69 Photo Astoria Column Detail Spotty Losses-AUG 1989

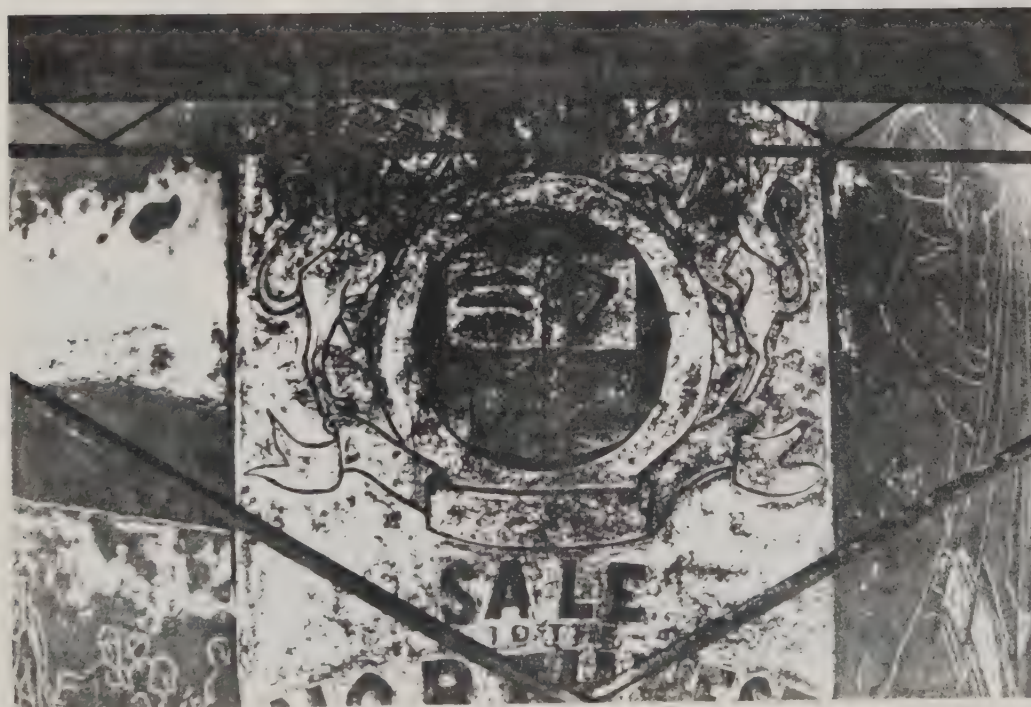
Fig. 70 Photo Astoria Column Detail Medallion "Spotty" Losses-AUG 1989

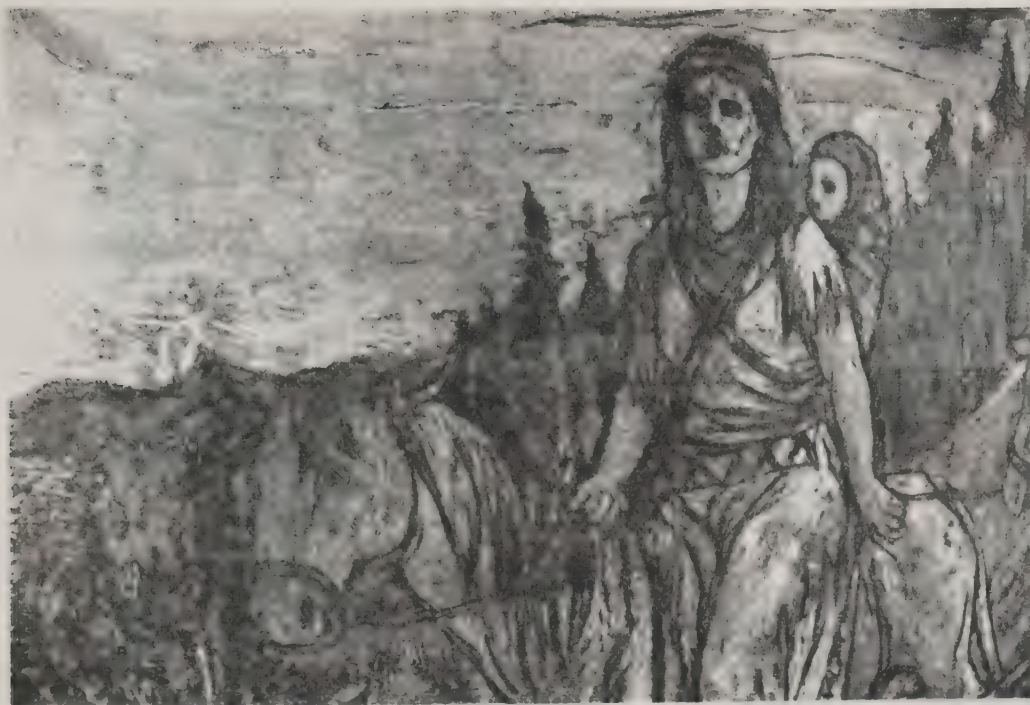
Fig. 71 Photo Astoria Column Detail "Intact" Sacajawea (Sa-ka-ka-we-a) And Baby Leading Expedition Across The Mountains-AUG 1989

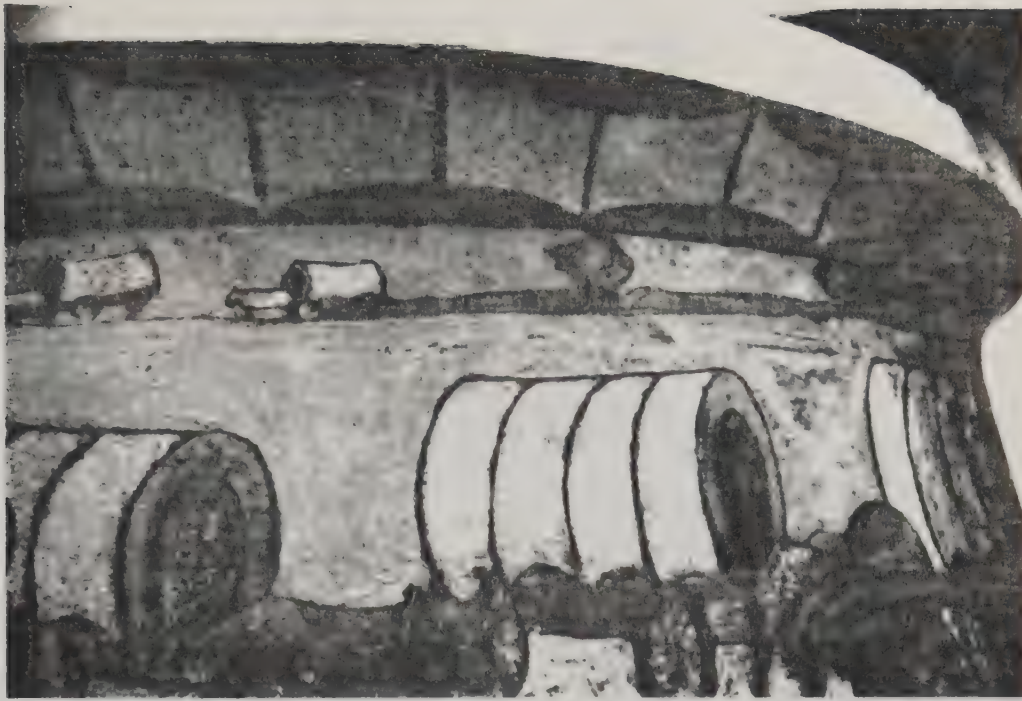
Fig. 73 Photo Astoria Column Detail Intact Design-JUL 1989

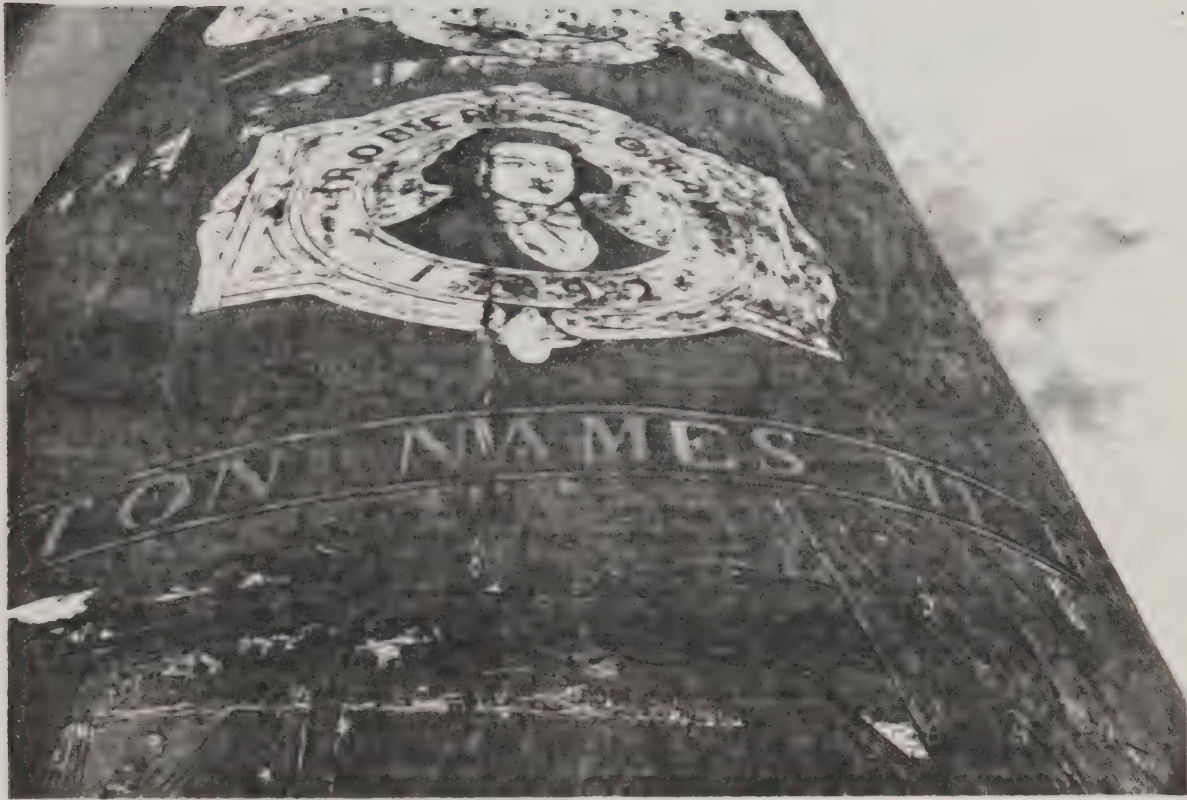
Fig. 75 Photo Astoria Column Detail of Vertical Crack

Remove all deteriorated and unsightly previous restorations, soil and algae from cracks. Fill cracks with a pigmented silicone elastomeric grout. Specification to be determined by conservator at time of treatment.

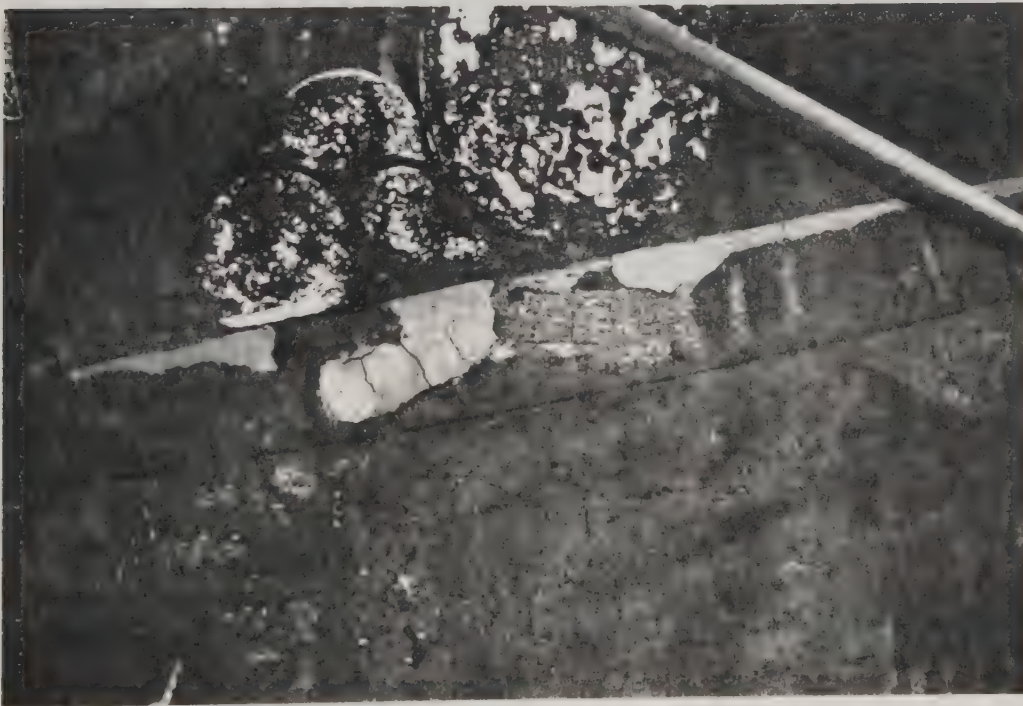
Several spalls are present on the southeast face. Some have been previously patched, some of the patches are deteriorated, some spalls are untreated. The spalls appear to be located where the re-bar was tied, and possibly slipped close to the surface. Moisture would cause the metal to rust, expand and damage the concrete. See Figure 68.

Fig. 76 Photo Astoria Column Detail Previously Patched Spalls-
JUL 1989

Remove deteriorated and unsightly previous restorations, soil and algae from spalls. Fill material to match brown base coat in color and texture. Formula for fill to be determined by conservator at time of treatment.

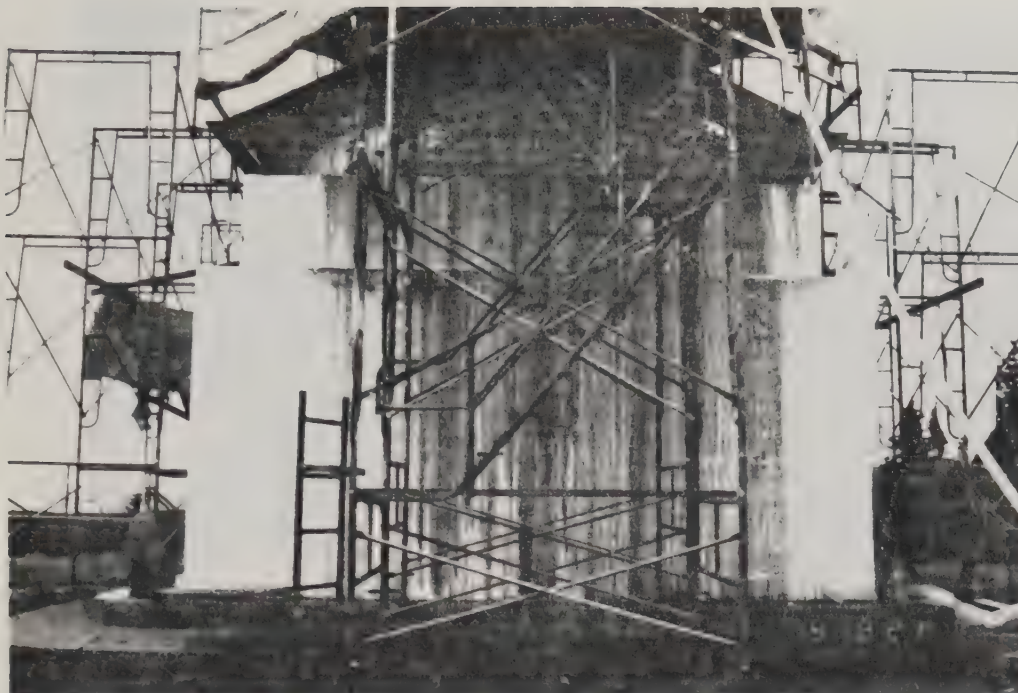
The layers of tung oil water repellent, which initially gave an artificial brightness to the artwork, have swelled and discolored to a dark amber, obscuring the color and design and preventing a valid assessment of the condition of the surface and the extent of color loss. The tung oil was removed during July and August of 1989. See Figure 69.

Fig. 77 Photo Astoria Column Detail Residue, Oil Removal-AUG 1989

Oils that may have migrated to the surface after the 1989 cleaning and soil that may have accrued since the 1989 cleaning may have to be removed before application of color layers.

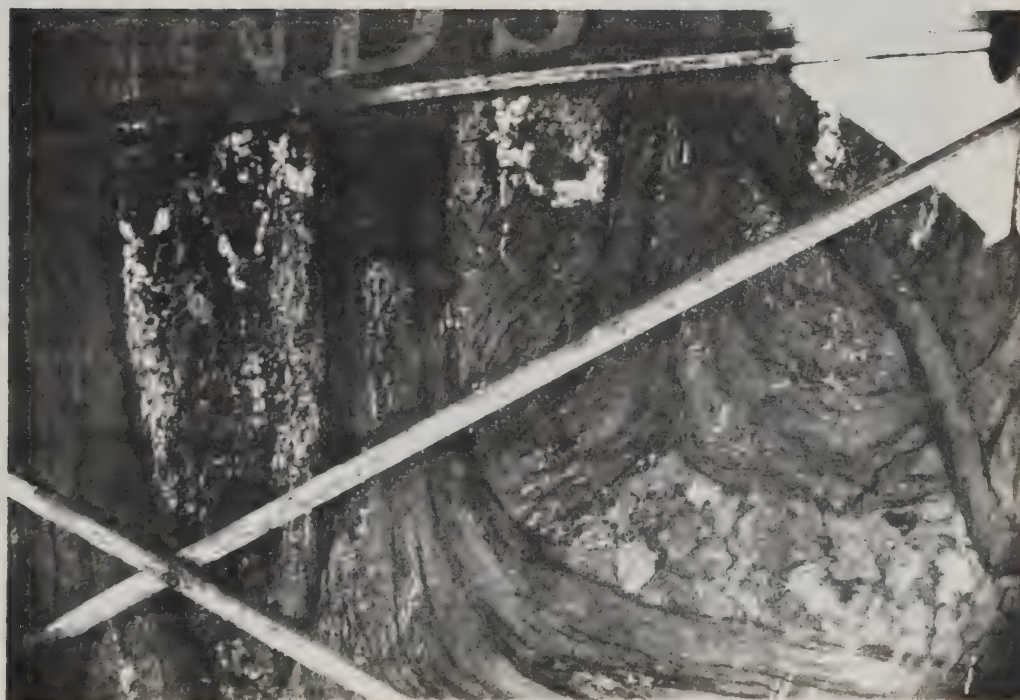
Figures 79 through 91 indicate the variety of design and intricacies of details.

Fig. 80 Photo Astoria Column Detail Carvings Lined in Black-JUL 1989

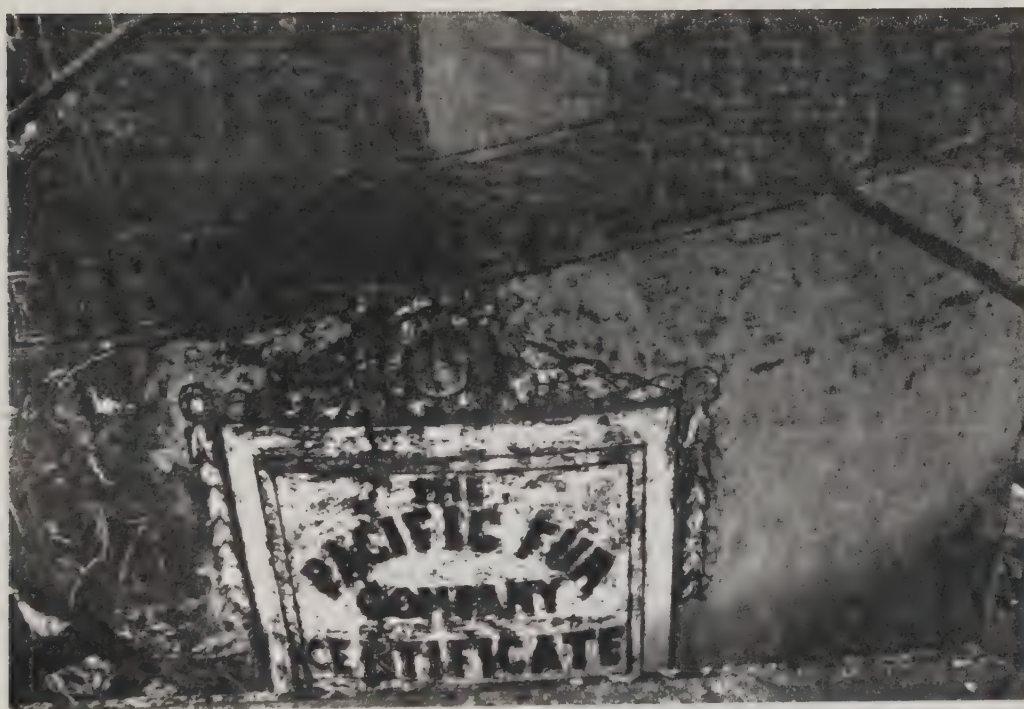
Fig. 83 Photo Astoria Column Detail Railway-AUG 1989
